Manhole Inspection Summary

Manhole # S29I__013MH

Insp Date: **9/8/08 8:09 AM**

Location Address: **121 Lemmon St**

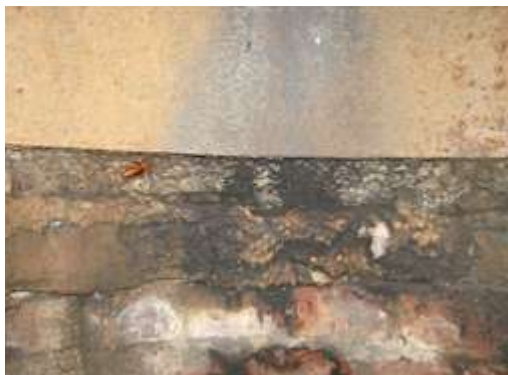
Miscellaneous

frame/lid infiltration

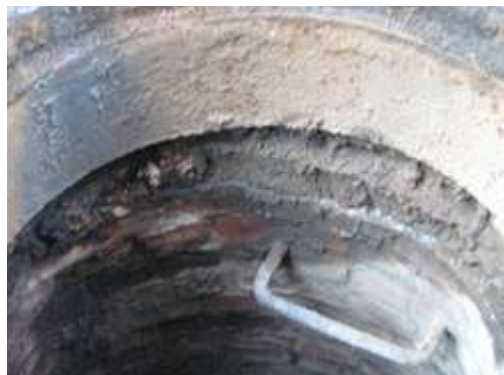
Miscellaneous

Additional view of infiltration at chimney/frame joint

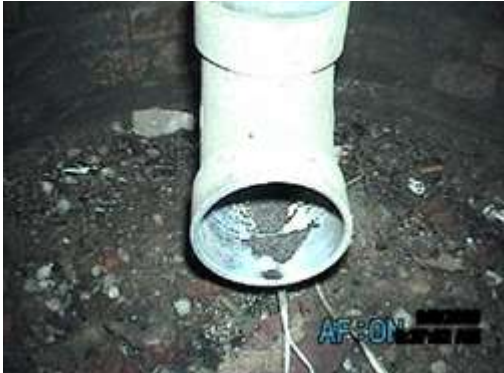
Defect 5

Condition: ☐ Sound ☐ Cracked ☐ Root Intrusion ☐ Deteriorated ☐ Leaks ☒ **Debris**

channel debris

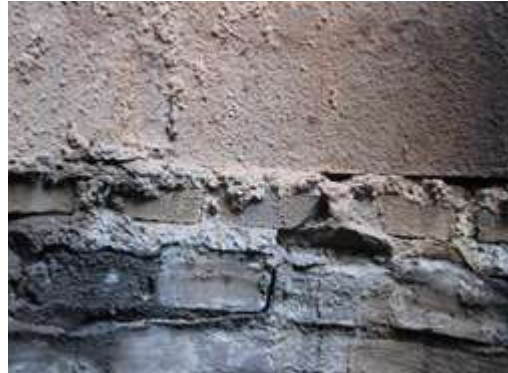
Defect 4

Condition: ☐ Sound ☒ **Cracked** ☐ Root Intrusion ☒ **Loose Brick** ☒ **Deteriorated**

chimney is deteriorated with cracked & loose bricks

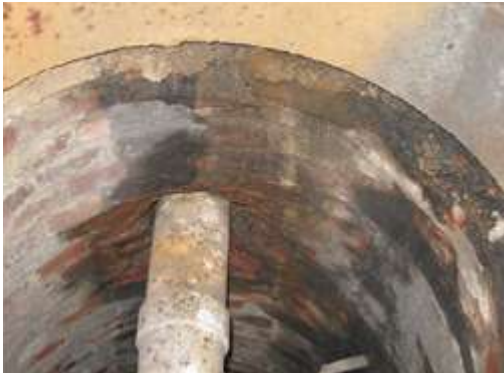
Defect 2

Infiltration: ☐ None ☒ **Joint** ☐ Cracks ☒ **Mortar** ☐ Roots ☐ Wall

Infiltration: ☐ None ☐ Joint ☐ Cracks ☐ Mortar ☐ Roots ☒ **Wall**

infiltration from chimney/frame joint & mortar. Also corbel wall infiltration around pipe in @ 12

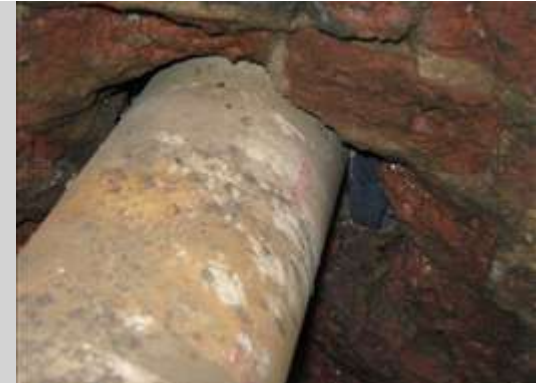
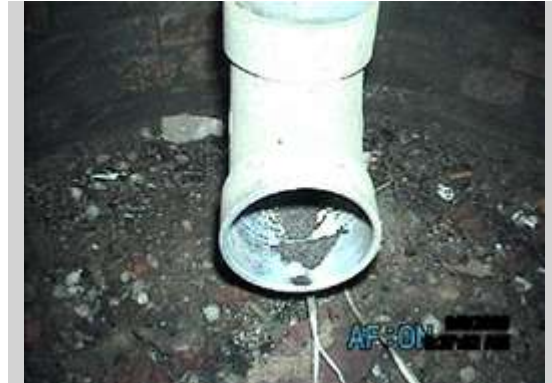
6 in. Circular Gravity Sewer
Pipe In @ 12 O'clock

Comments **Pipe has an incoming 12 see pics, illegal connection?**

Pipe Height: **40.8** (in.) Rod and Bar (Angled)
Pipe Material: **PVC** ☐ Pipe Lined
Invert Depth: **0.00** (ft.) Flow Characteristics: **None**
Deposits: ☒ None ☐ Mud ☐ Sludge ☐ Debris ☐ Grease
Silt Depth: **0** (in.) Deposits Extent:
Infiltration: **None** Pipe Seal Cond: **Sound**

Drop: Inside	Direct
Angled:	Reading: 7.18 (ft.)
	Inv Depth: 7.36 (ft.)
Drop Condition: Open	
Connects To: Connecting Node Not Available	
<input type="checkbox"/> Possible Illicit Connection

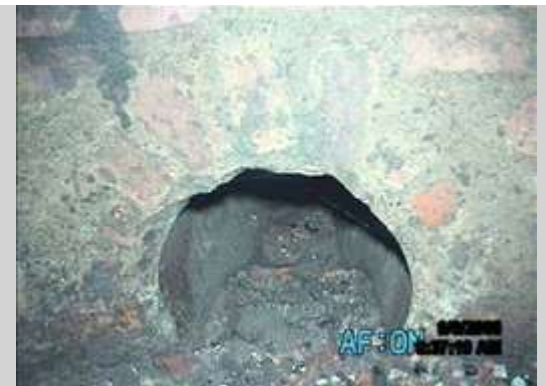
10 in. Circular Gravity Sewer
Pipe Out @ 12 O'Clock

Pipe Height: **10.8** (in.) Rod and Bar (Angled)
Pipe Material: **Clay** ☐ Pipe Lined
Invert Depth: **8.92** (ft.) Flow Characteristics: **None**
Deposits: ☐ None ☐ Mud ☐ Sludge ☒ Debris ☐ Grease
Silt Depth: **0** (in.) Deposits Extent: **Light**
Infiltration: **None** Pipe Seal Cond: **Sound**
